Inspection Photos

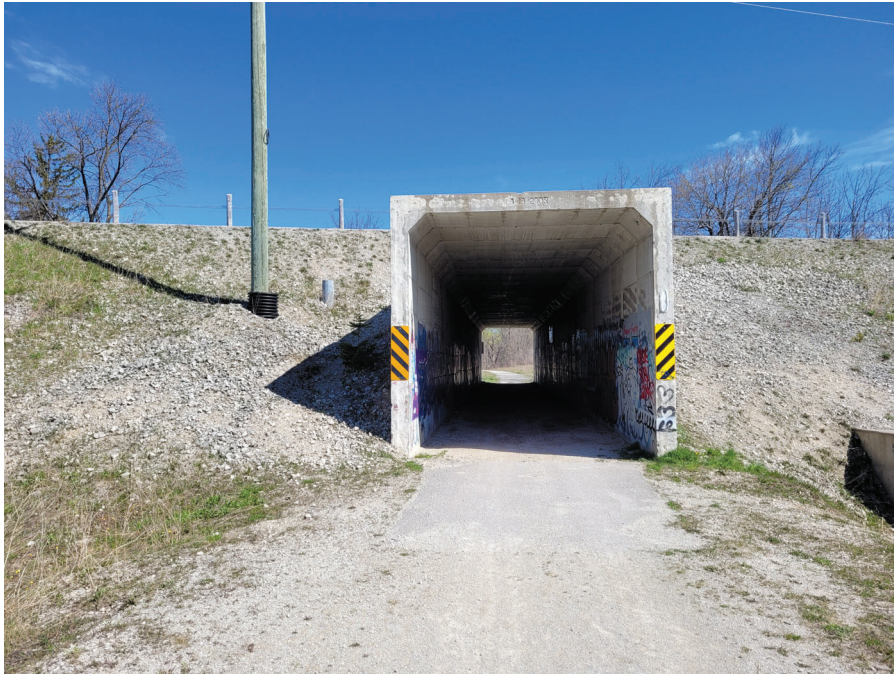
View of structure facing north.

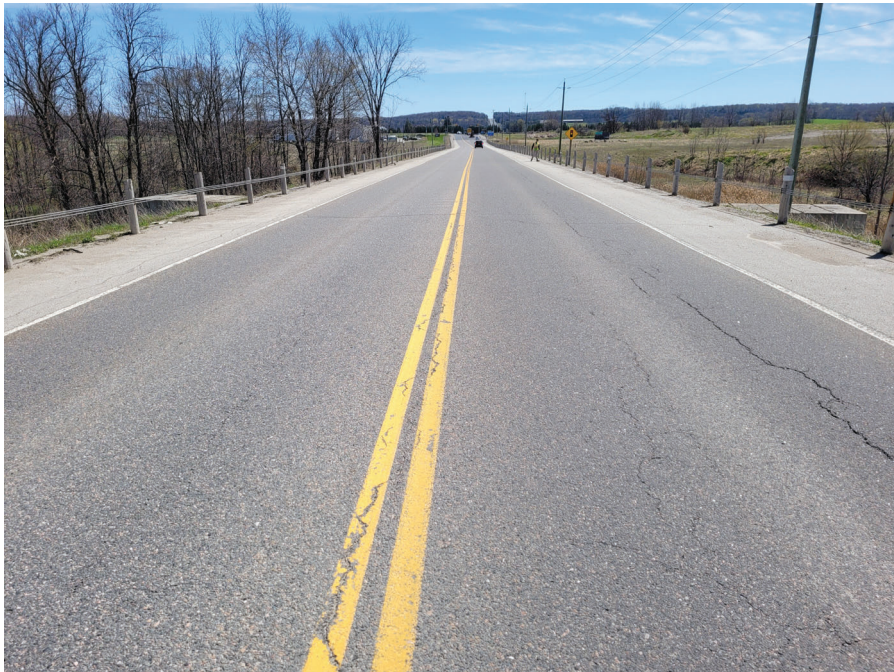
View of structure facing east.

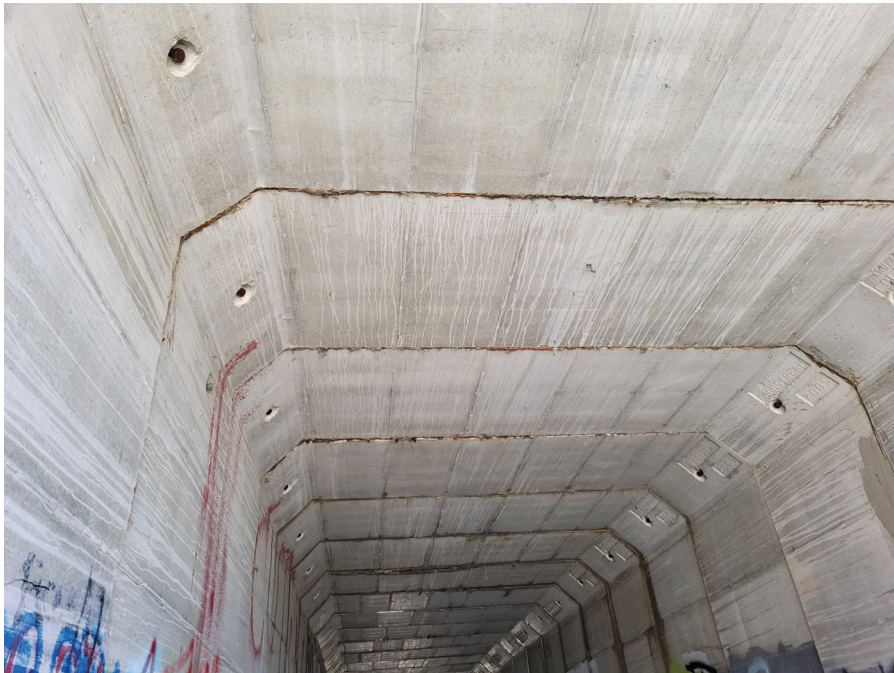
View of soffit.

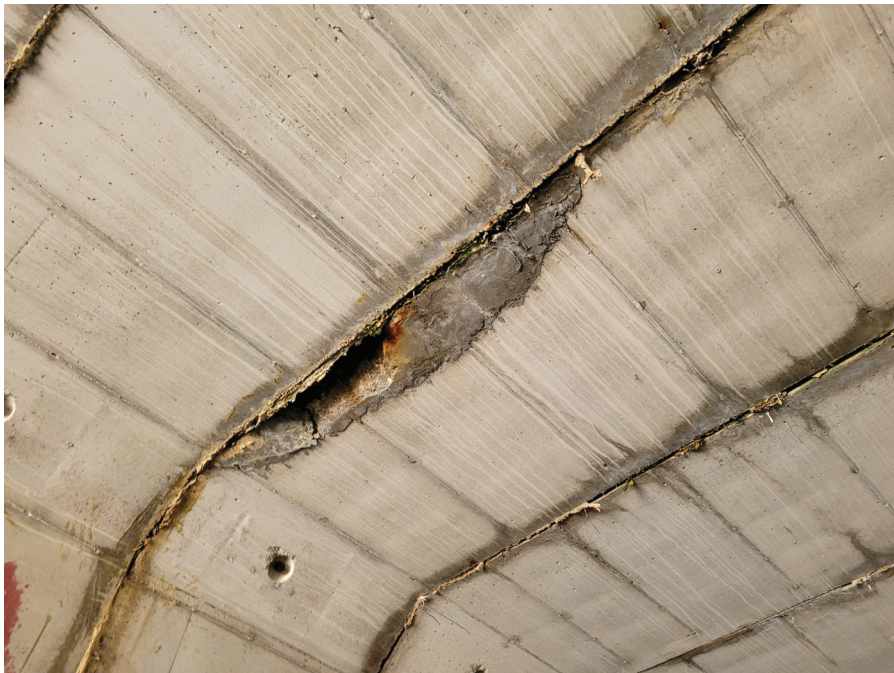
View of severe spall on central soffit.
