Walking Beam Flocculator Photos

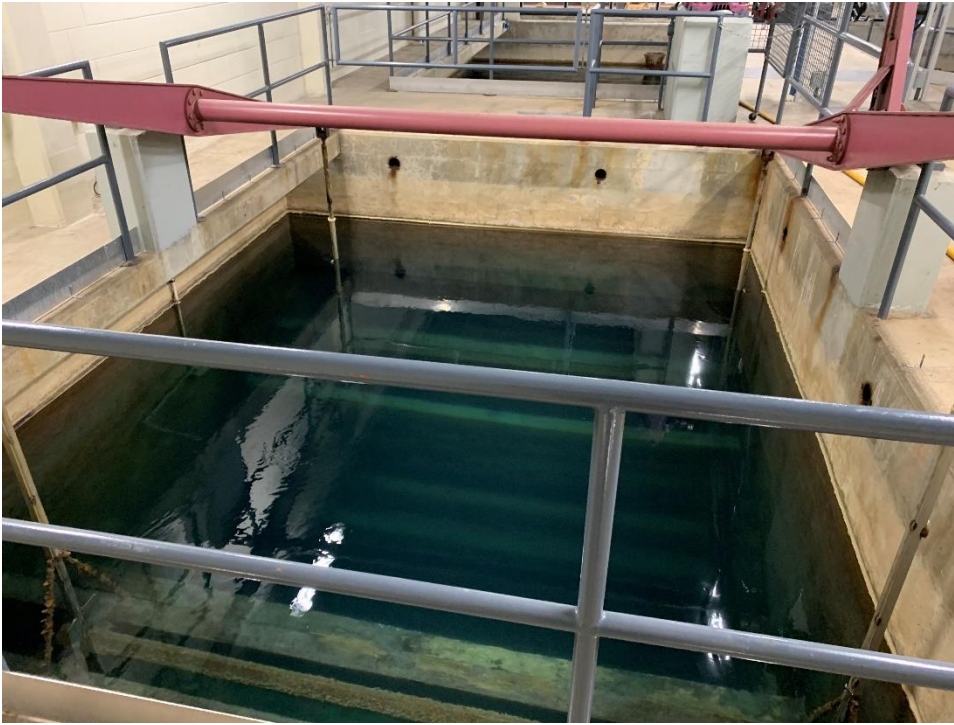
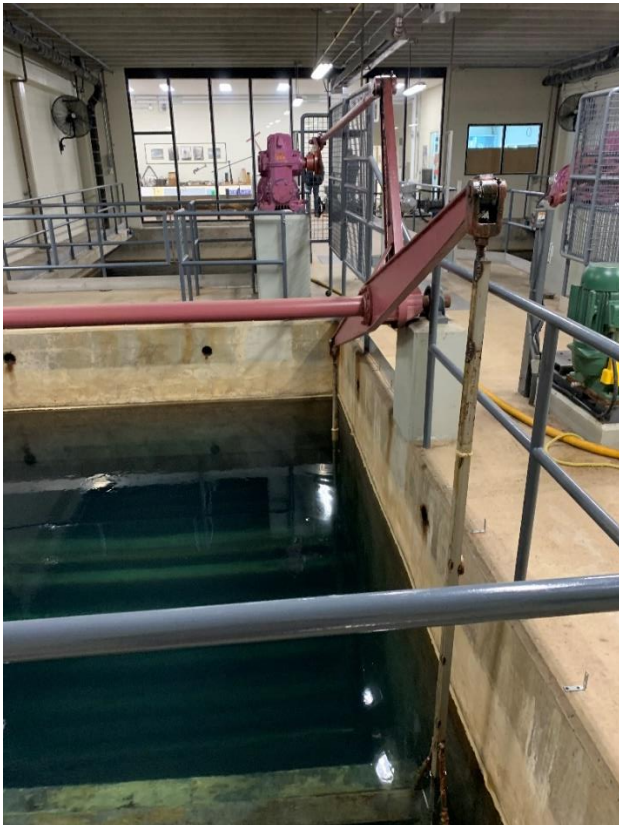
Intact Walking Beam Flocculator

Note the wooden mixing “paddles” suspended from the beams that rock back and forth to repetitively lift and lower each side, thereby mixing the water in the flocculation tank.

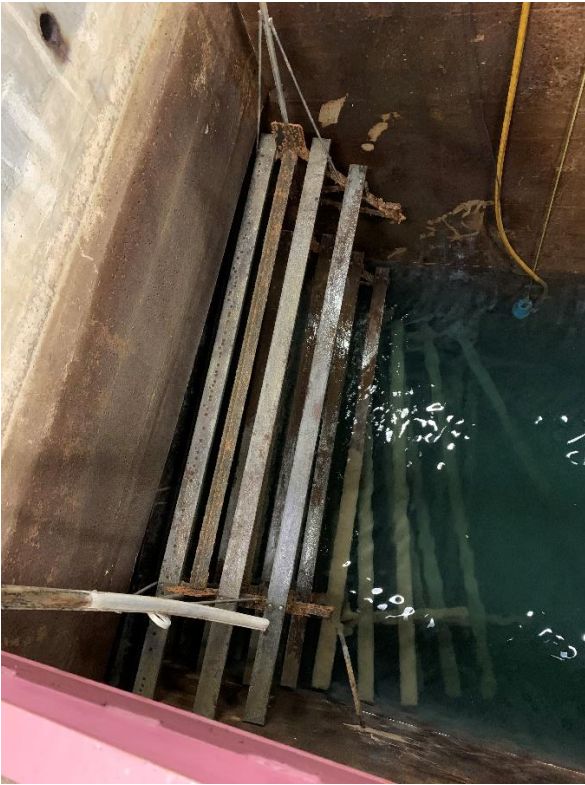
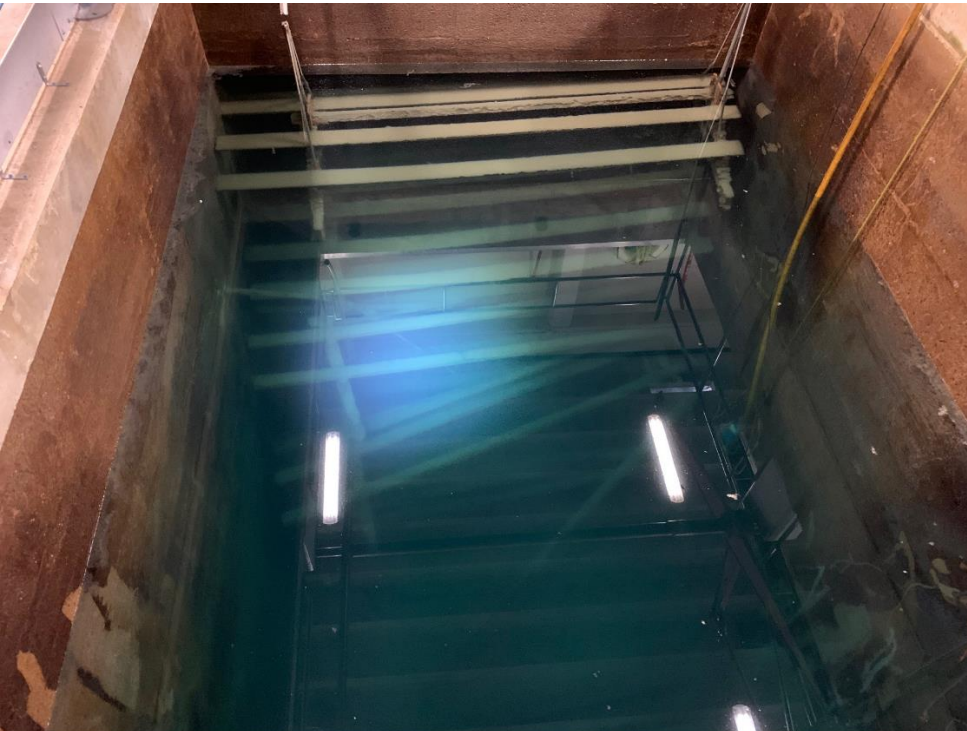
Damaged Walking Beam Flocculator

Above left and below: The “paddles” have fallen to the bottom of the tank.

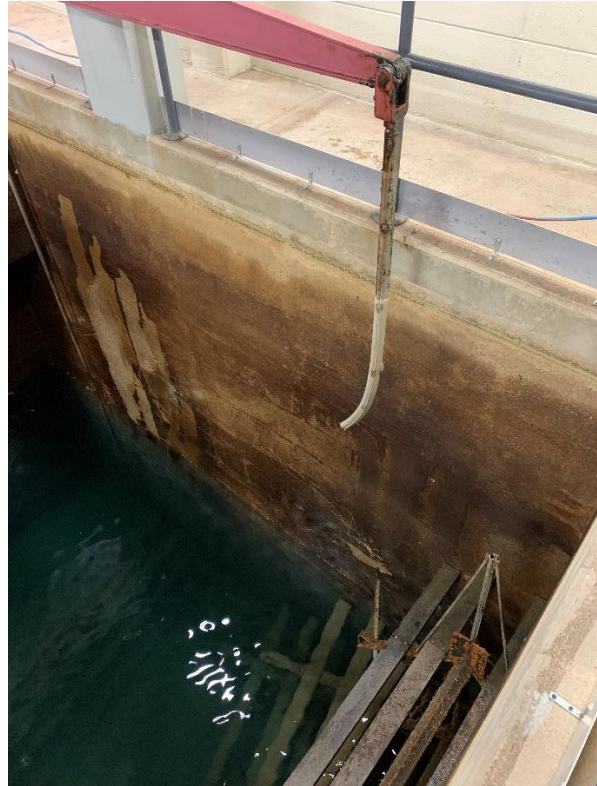
Above right: Broken suspension rod

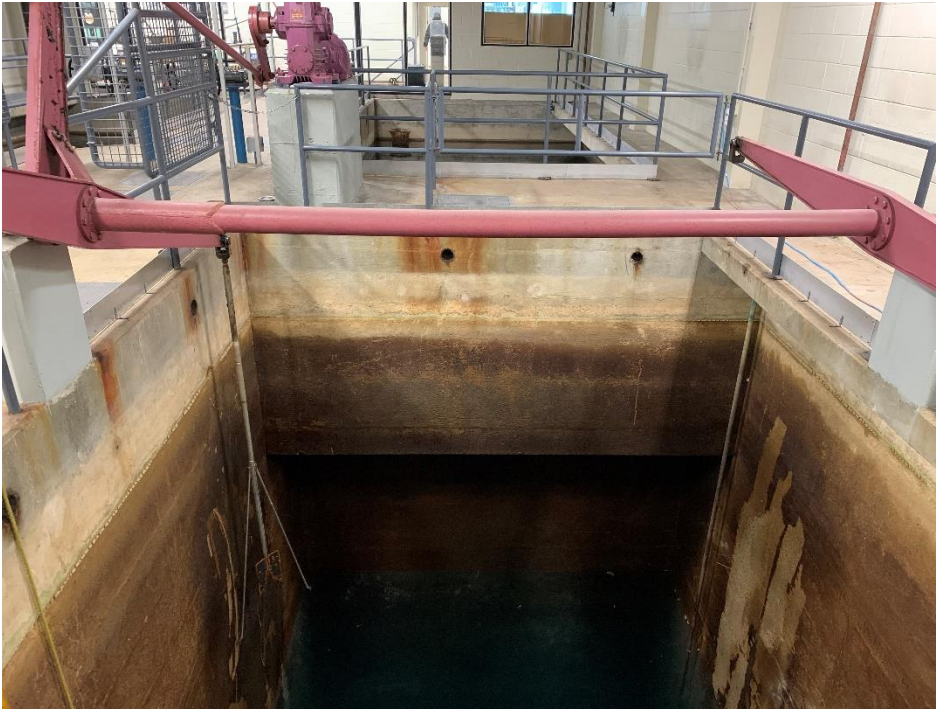
Above: Bowed axle rod. In background, the rusted-through connection of one of the mixing paddle assemblies can be seen suspended from the rod

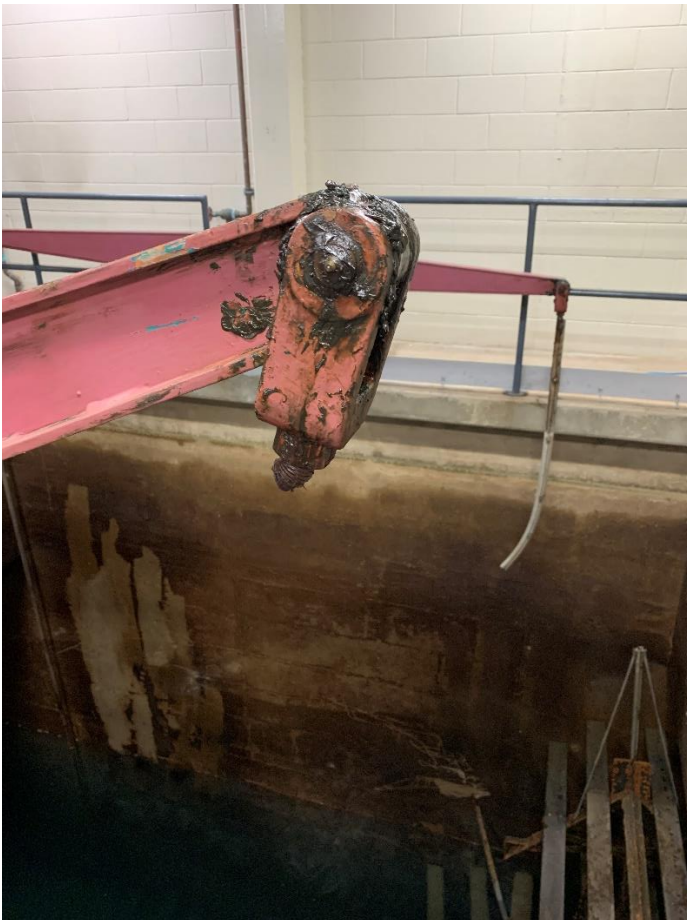
Below: Suspension rod snapped at beam connection
