Staff Report

Report Code: CR-25-083

Subject: Centennial Tower Structural Assessment and Capital Needs Update

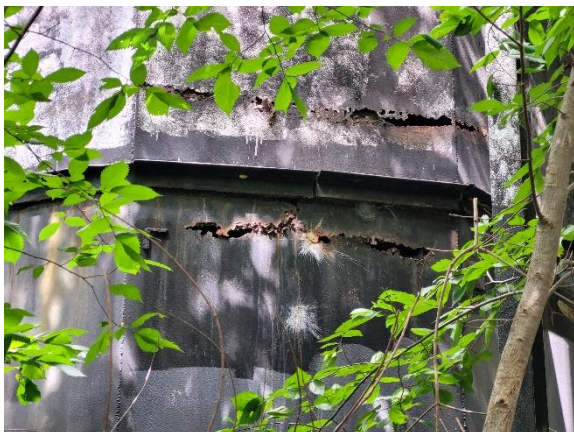
Immediately upon the completion of the on-site assessment, staff from GEI contacted the City to notify staff about structural concerns that needed to be addressed prior to public use of the tower. The most notable concern was considerable corrosion and section loss of the eastern steel panels that support the upper concrete tower and make up the lower portion of the tower.

GEI recommended that the tower be closed to the public until the City could address structural concerns, as well as pressing issues that were later identified in the structural review report. Parks and Open Spaces installed temporary barriers and signage on August 23, 2024, based on the recommendations of GEI and later replaced the barrier with a more permanent barrier, as well as formal signage on the Centennial Tower wayfinding signage to inform the public of the closure. The barriers, signage, and closure are still in effect.

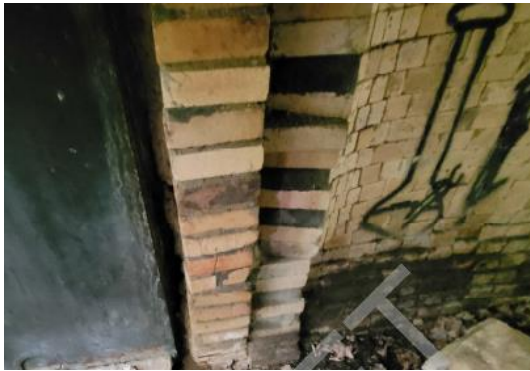
It was also identified that the entrance arches of the inner brick layer, supported by the steel panels, are showing signs of deflection, and some bricks have shifted.
