Staff Report

Report Code: CS-19-154

Subject: Application for Demolition or Removal of a Structure Designated under Part IV of the *Ontario Heritage Act*: rectory of St. Mary's Roman Catholic Church, 554 15th Street East

The Rectory for St. Mary of the Assumption Roman Catholic Church, Owen Sound The Roman Catholic Episcopal Corporation of the Diocese of Hamilton in Ontario

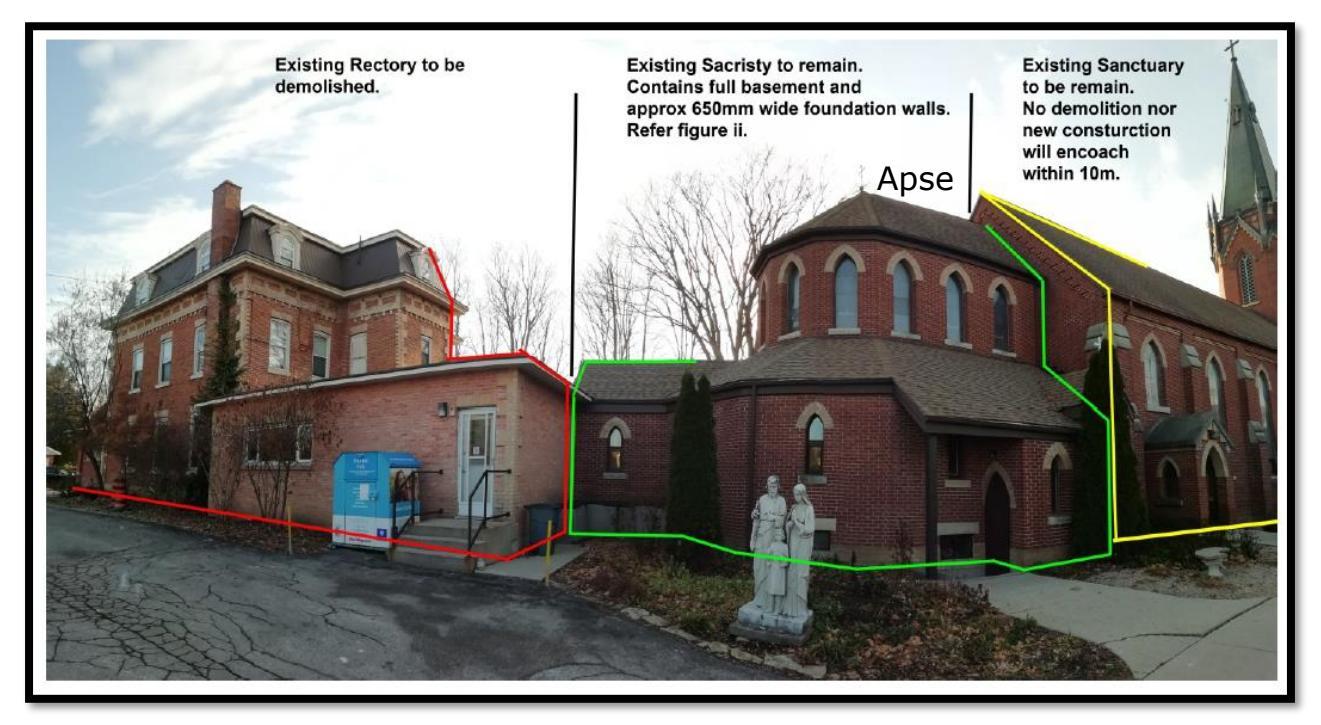
Figure 1: Excerpt from Demolition and New Construction Strategy by GM Diemert with emphasis added

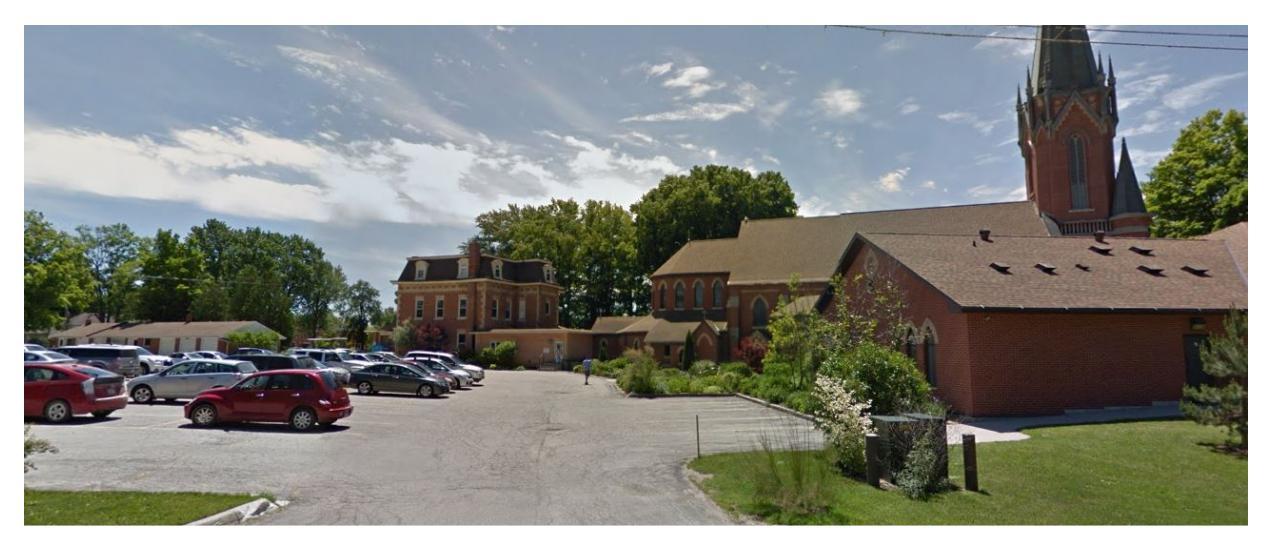
Figure 4 depicts the site as viewed from the 16th Street East entrance and it clearly demonstrates that the rectory competes for the visual primacy that is ideally reserved for the church. Figure 5 shows the site as viewed from 6th Avenue East. The rectory not only competes for visual hierarchy, but it generally obscures the church.

Figure 4: A view from 16th Street East.

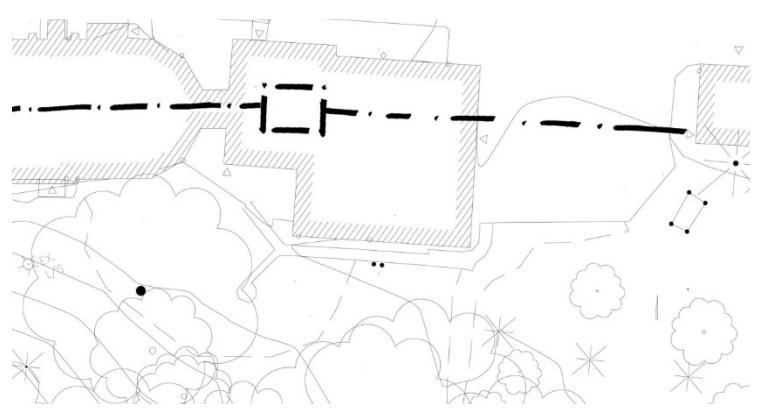
The 1871 sanctuary has a central aisle that connects the western front doors to the altar located in the eastern end of the church thus forming an axis. The pathway leading up the escarpment joins the western end of this axis at the front doors of the church. The axis is likewise continued out of the rear of the sacristy via the central door to connect with the existing rectory's former vestibule (the frontispiece) which contained the front door and vestibule within the 1872 rectory. The 1872 rectory has a centre-hall floor plan which, therefore, continues the axis through the rectory and out onto the formerly open, 1917 verandah. The relationship between rectory's frontispiece and the rear door of the church and the space initially between rectory and church is obscured by the 1977 kitchen addition and prior to that, the circa 1900 kitchen addition. The axis is skewed slightly since the rectory is not perfectly aligned to the church's axis. This axis and the skew in it are preserved in the new design. The frontispiece is also marked by a rectangular brick form that recalls the form of the frontispiece.

Figure 8: the west to east axis developed by the church is continued into the existing rectory's former front door and through the centre-hall plan.

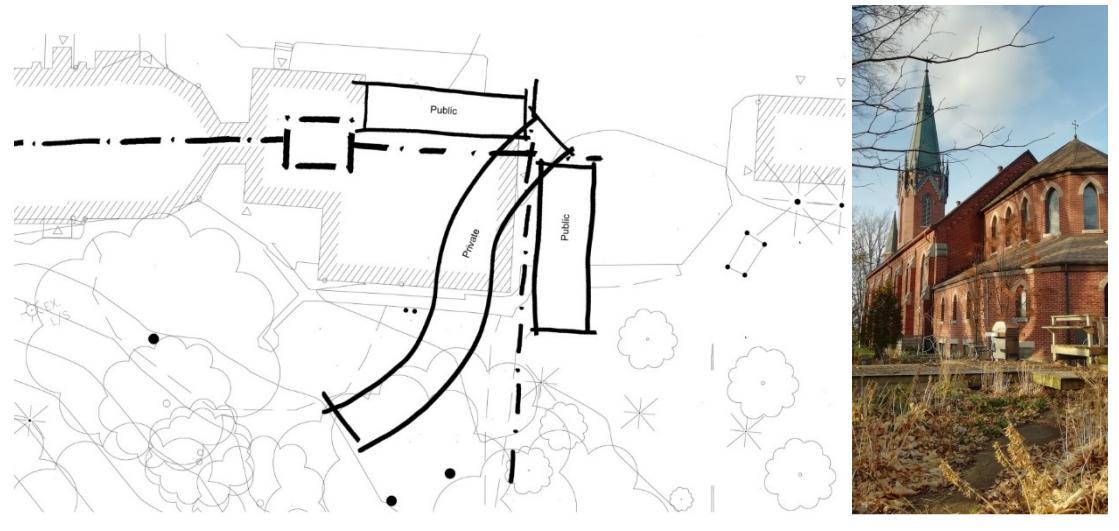
The new rectory addresses the public spaces with its northern and eastern facades. It provides a private courtyard for the priests which has a more relaxed geometry that is derived from the shape of the apse of the church. The courtyard is focused on the apse and sacristy and toward the landscape along the southern flank of the church. Refer to Figure 10 which depicts the approximate view of the three suites designed as individual private quarters for three priests.

Figure 9: Public and private territories.

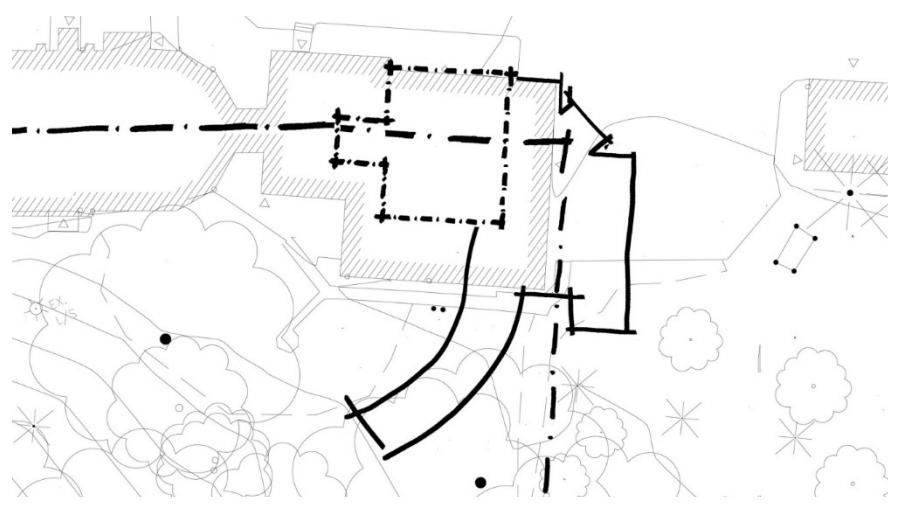
Refer to Figure 11. The original 1872 rectory's position and outline is preserved within the design of the new building. The frontispiece becomes a new brick form, the northern wall is replaced by a new wall in the same location and the northern side of the former central corridor of the 1872 brick core of the former rectory forms the main collective living room and kitchen. The main interior passage takes the place of the central hall of 1872 and the rooms formerly south of the centre hall are replaced by an exterior terrace which has its southern boundary marked by the position of the original southern wall of the 1872 building.

Figure 11: The imprint of the 1872 brick shell and frontispiece in the new floor plan.

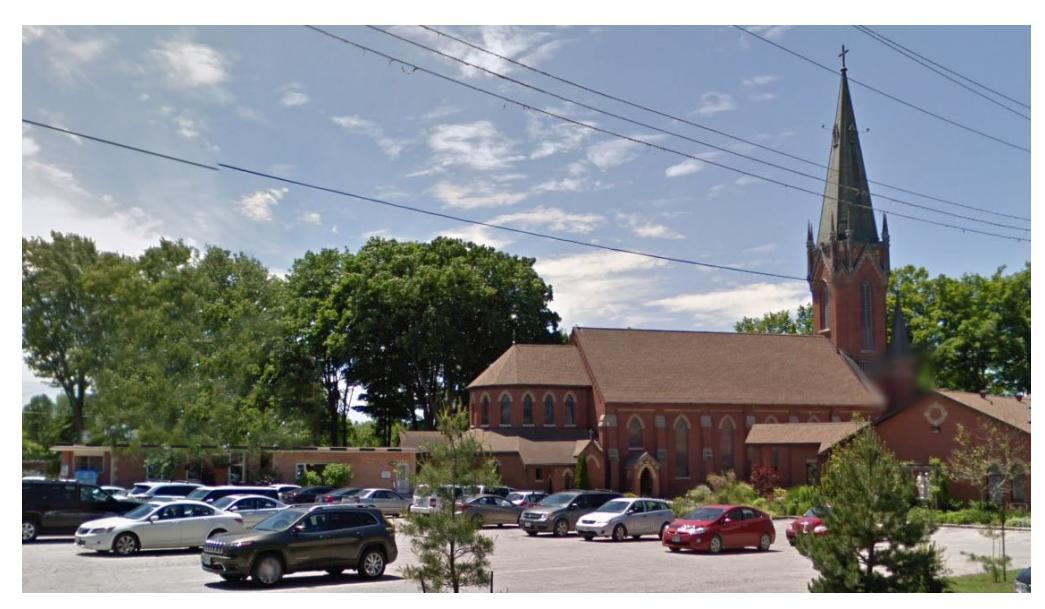
Figure 13 illustrates the approximate effect of the reduced height of a new rectory. The Figure 13 image is made by altering the photograph to remove the upper levels of the existing rectory. The new design is not inserted into the image. Refer to Appendix A, view corridor studies for the relationship between new rectory and existing church.

Figure 13: An approximation of the effect of a one-storey rectory.

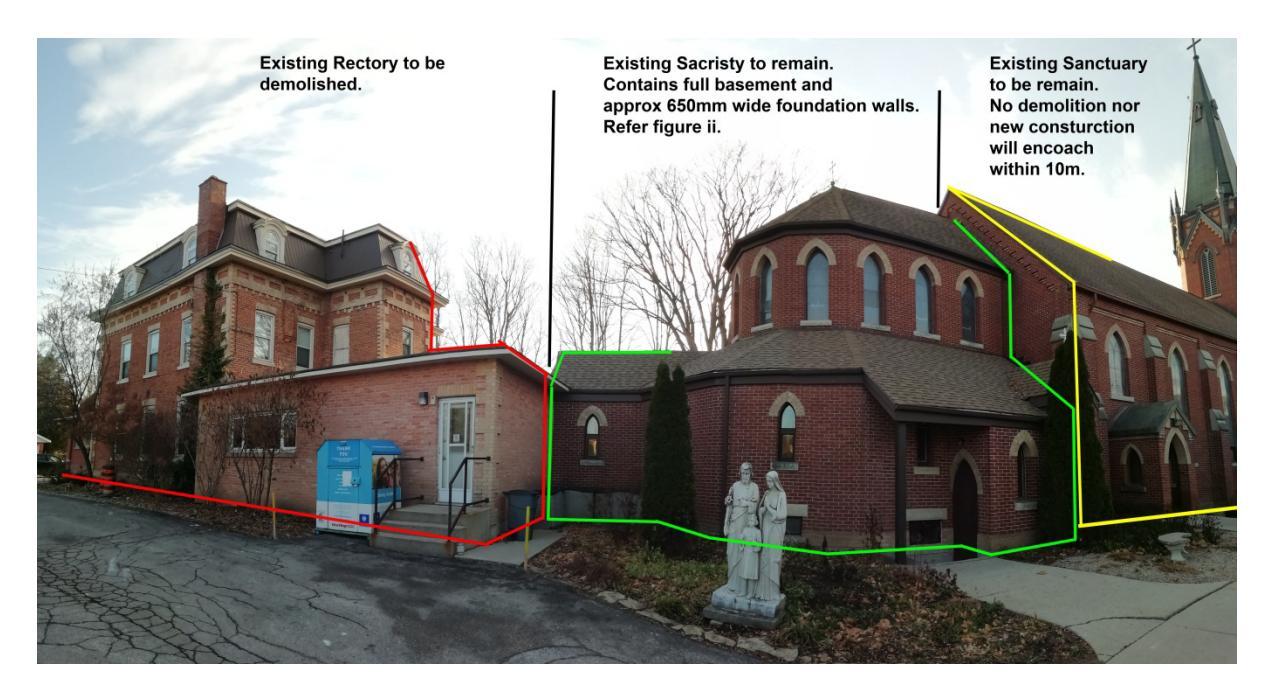
- .1 Identification of buildings and description of the existing situation:
- Refer figure i Building Identification and Description.
- **The original church** is now the sanctuary: The current sanctuary and the steeple were completed during 1871 are constructed on rubble stone walls with mortar in the joints. There is a crawl space with a central aisle of walkable height below the sanctuary and there is exposed earth throughout the crawl space. The crawl space is accessible from a hatch located within the original eastern wall of the sanctuary foundation wall that now separates the sacristy's basement from the sanctuary's crawl space. The earth below the church appears to be a gravel and sand mixture which is dry over the entire surface. The material appears to be stable and the sides of the central walkway are not collapsing.

Figure i: Buildings - Identification and Description

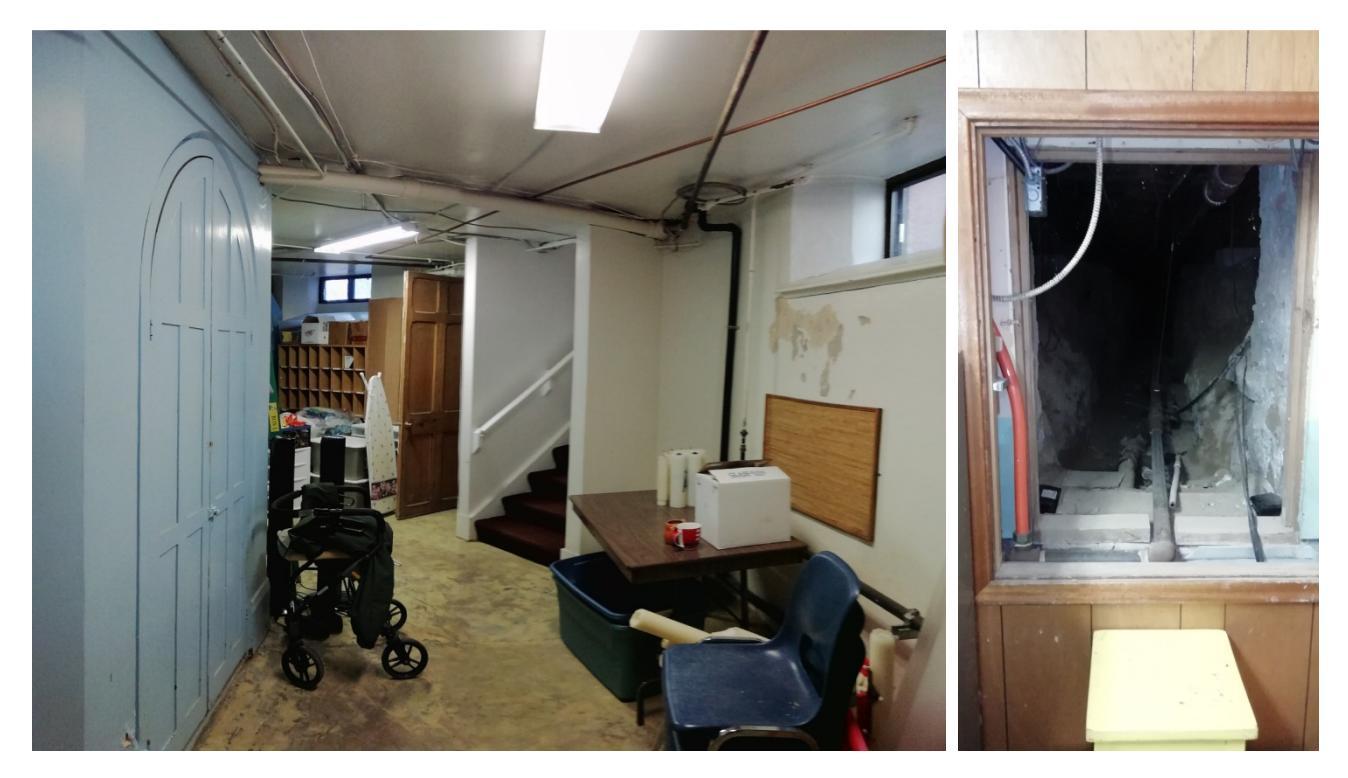
that had pews, an organ and a seating capacity of nearly 100. The basement has a concrete floor and the foundation wall is visible within it. The foundation wall is finished with mortar parging which is typical of this time period and the parging is painted where it forms part of the finished space. The interior of the basement is partially finished as useable space and it had been in use as office space in recent memory. Added to the central face of the sacristy apse (the segment of the apse that faces east) is an extension which contains a corridor connecting the Sacristy to the rectory and a staircase leading from ground level to the basement of the sacristy. The apse is nearest the proposed new construction and the exterior side of its foundation will be exposed during demolition of the rectory and during the new construction of the proposed rectory. Although an exact foundation wall thickness cannot be determined at this time, the foundation wall appears to be in excess of 650 mm thick.

Figure ii - Sacristy Basement

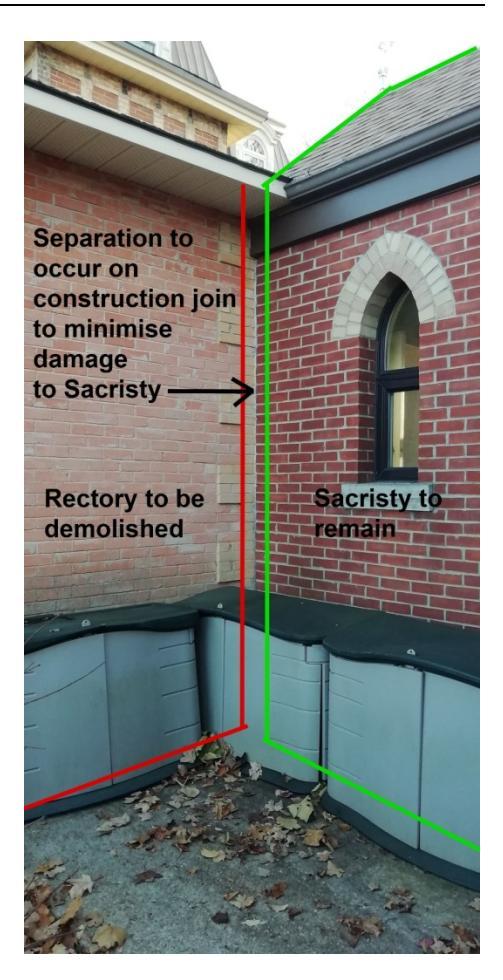
- The balance of new foundation construction occurs a distance of approximately 6.2 meters or approximately 20'-4" from the sacristy extension. This separation will ensure that very little serious excavation and construction work will take place near the sacristy following removal of the current rectory's kitchen.

Figure iv - Existing construction join between Rectory and Sacristy

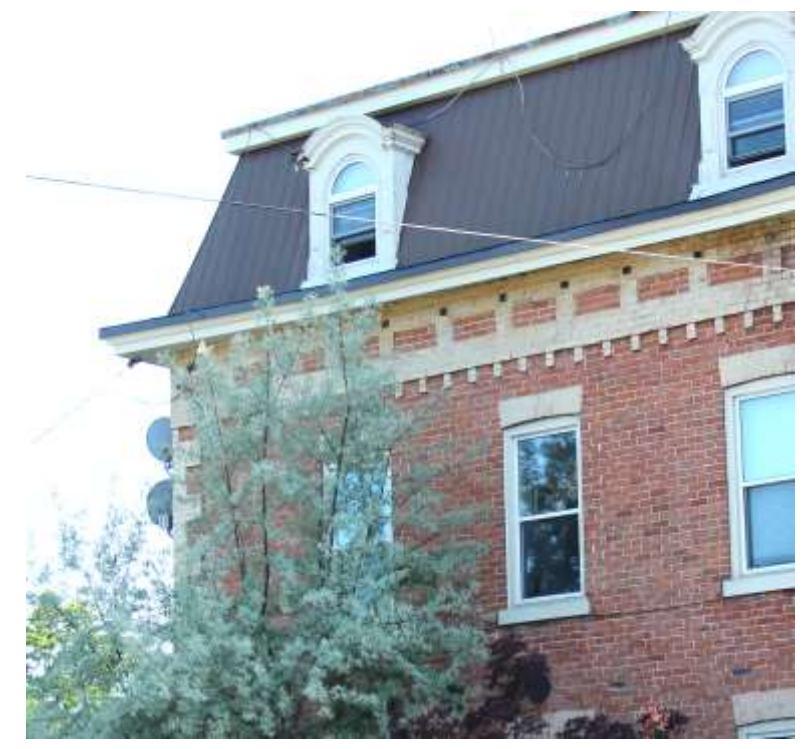
Figure 42 - View of details in mansard roofline, bi-chromatic brickwork, window arches and dormer. (Photo: RHC 2018)

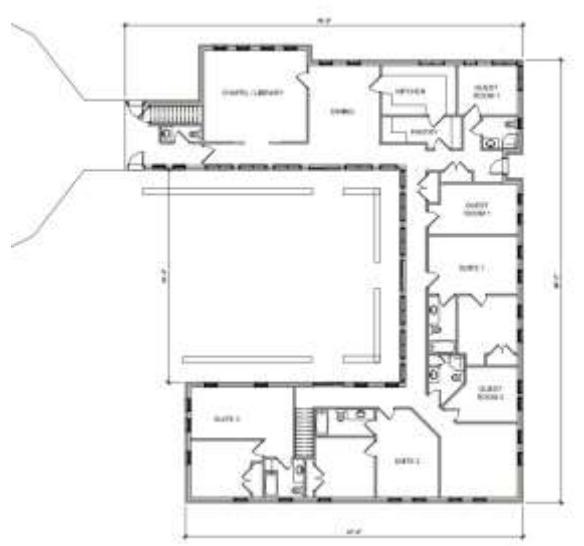
There is an attempt in this design to build suites around a courtyard with natural space in a private setting. It is intended to have a

Figure 46 - Main Floor plan for proposed new rectory. (G.M. Diemert Architect Inc.)

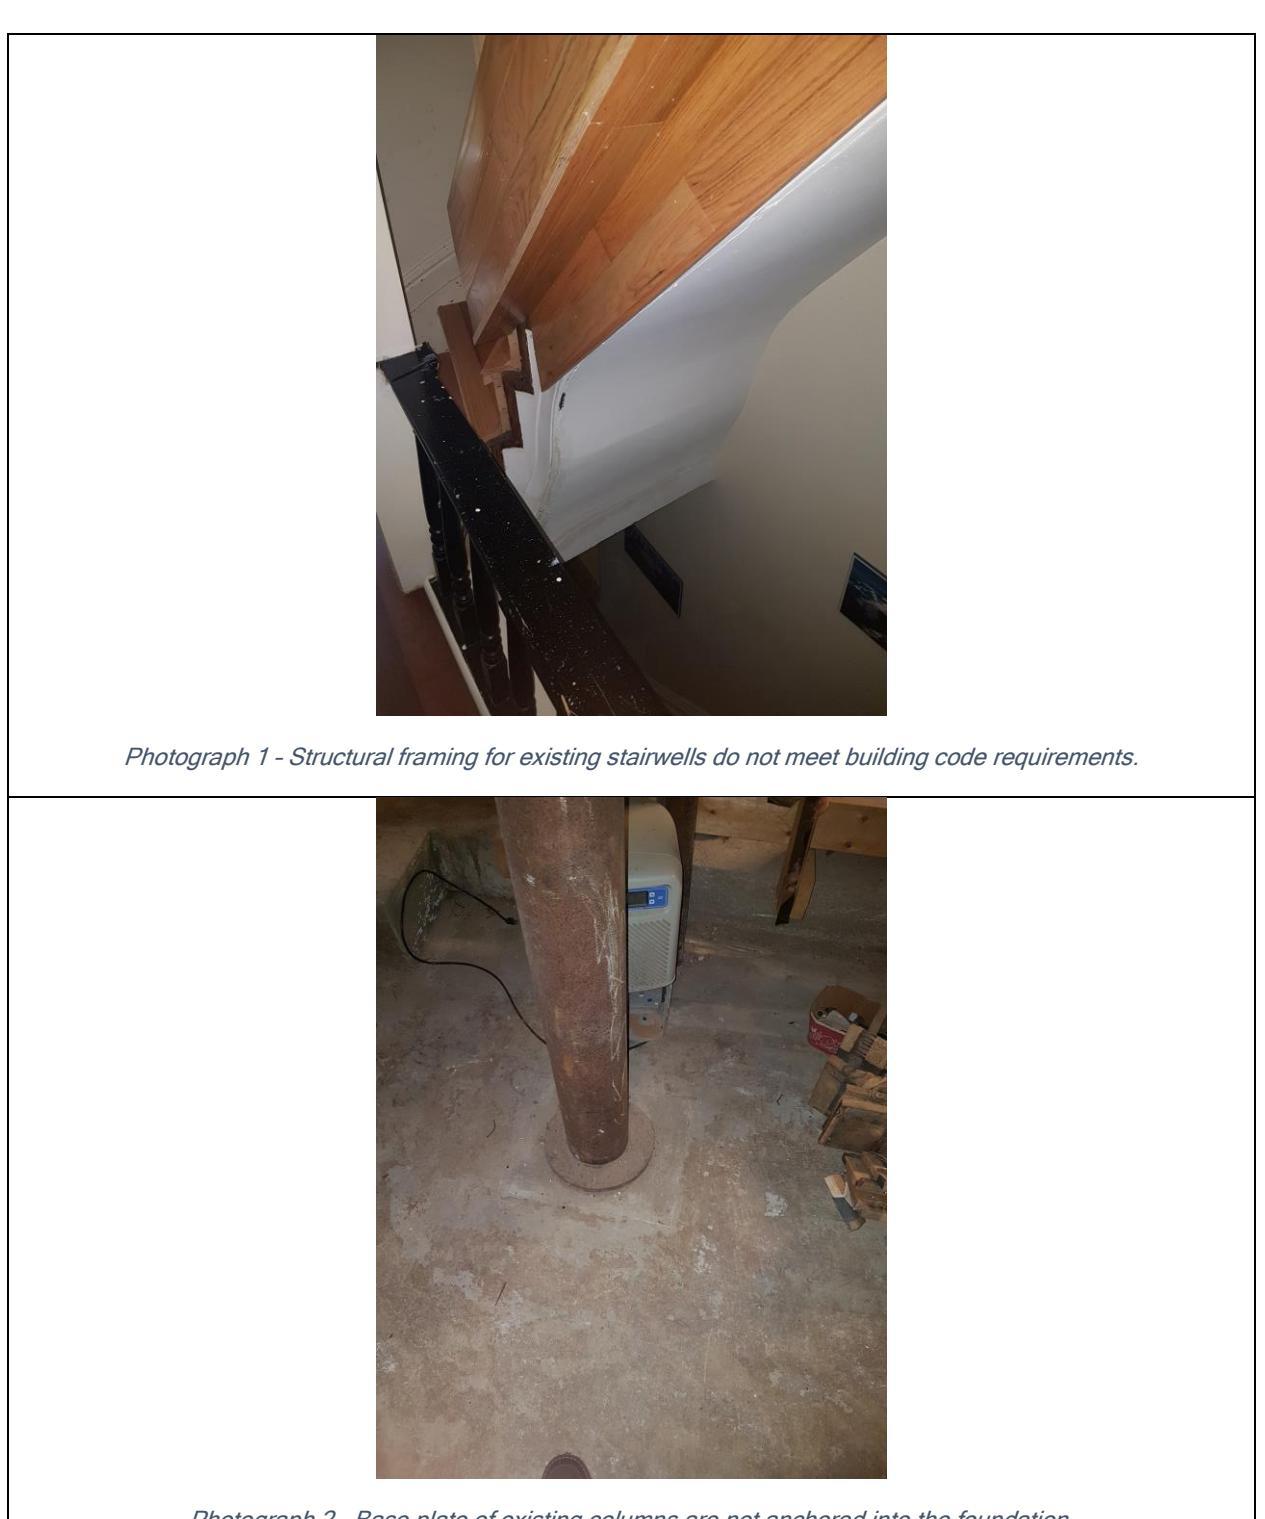
Photograph 2 - Base plate of existing columns are not anchored into the foundation.

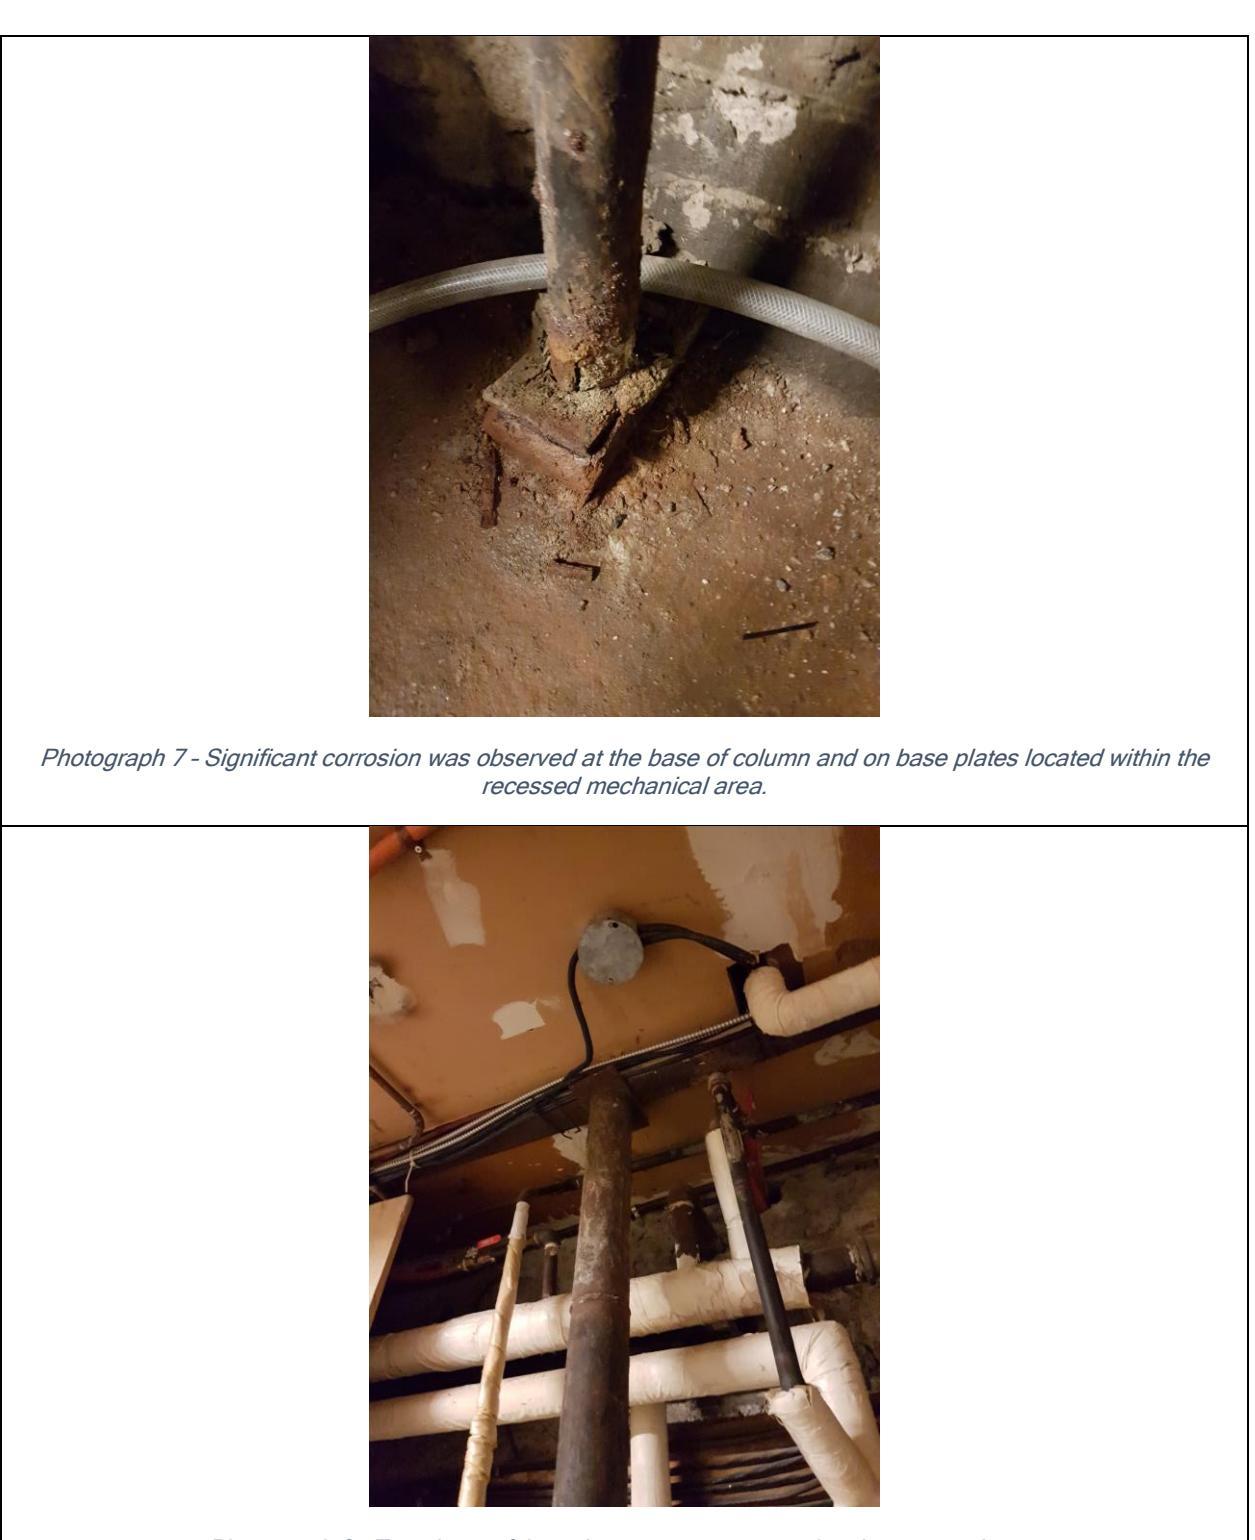
Photograph 8 - Top plates of the columns are not secured to the support beam.
